# STONE FENCES and FEATURES of the LOWER COAST – A FIELD TRIP REPORT

By C. Martin, R. Lewis, and T. Fosnaes of the Sir William Vaughan Project

21 October 2012

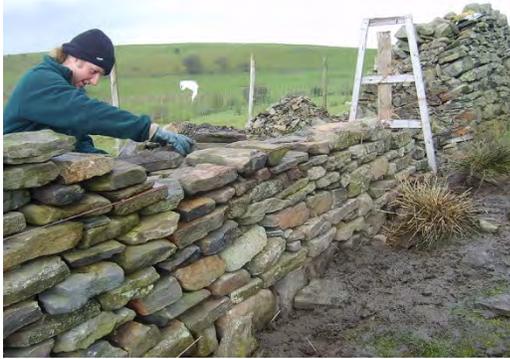
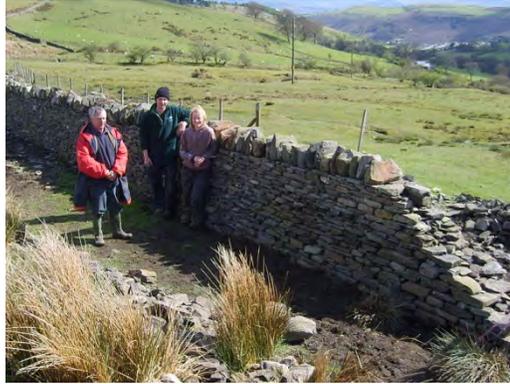
This is an adequate description of the fences found east of the Powles Point road although the Lower Coast fences appear wider at the base than the description allows or as is shown in the Welsh example photographed below. As well, some centuries of disregard may now disguise their original condition.

Pictures 1 and 2 A Welsh example from the *Rock fence* website.

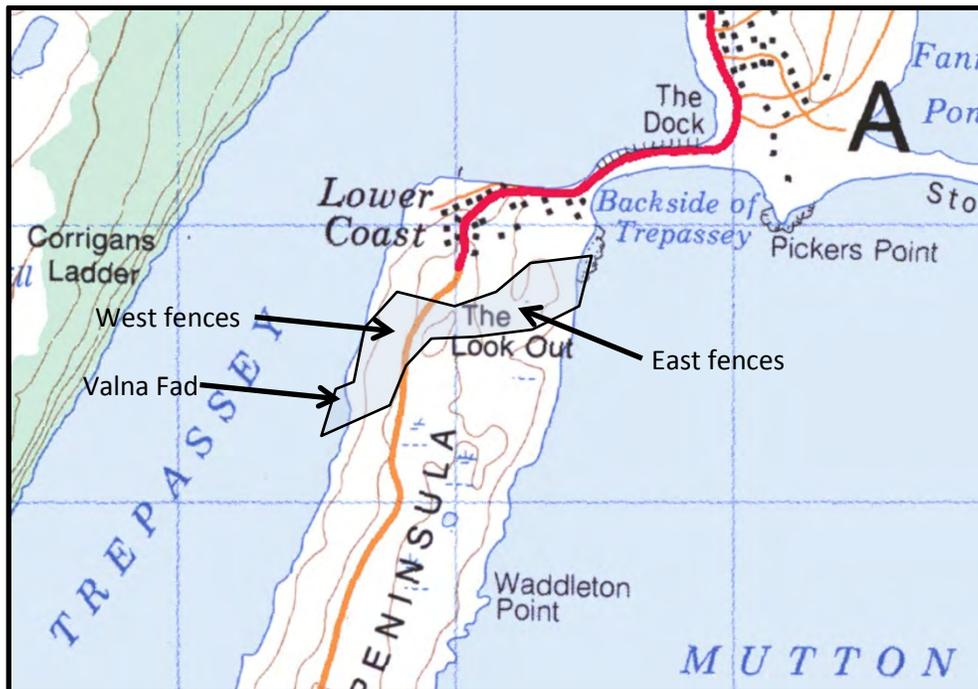
Figure 1 Section of Canadian topographic map 1K12 showing study area at north end of Powles Peninsula

The Lower Coast hinterland rises from the north shore of the Powles Peninsula (Figure 1). What appear to be raised seabeds are topped by a 19<sup>th</sup> century battery, now an historic and interpretative site. The battery commands the entire Lower Coast as well as the narrow entrance into Trepassey harbour. The road to Powles Head lighthouse follows the high ground of the central peninsular ridge. The area contains many stone fences and other stone features.

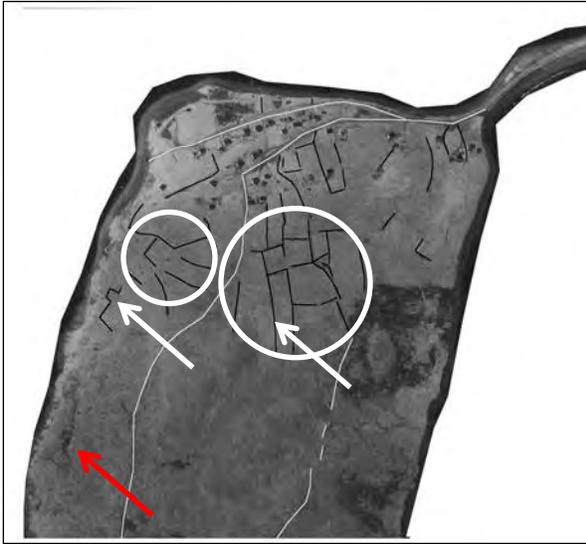
**Picture 3** This 1950's aerial photograph (left) of the Lower Coast area has fence lines traced in black; subsequent observation shows many of the northern (top) fences are wood and wood and wire fences. The stone fences visited in October 2012 are indicated by white circles. The white arrows indicate possible *folds* or *pounds*. The red arrow indicates Valna Fad site.

Generally the fences west of the road (3, thin white line) are of much rougher construction (thrown and piled) than are those east of the road, but they are orderly as are the east side fences. *Gate* features are found near center of the smaller white circle. Fencing southwest of the smaller circle (west of the road) shows a three-sided enclosure (white arrow) built into the wall, similar to one discovered at an east side fence and nearby to the south, the Vlna Fad site is marked with a red arrow. Between 12 and 2 o'clock on the small circle are flattened areas containing stone structures.

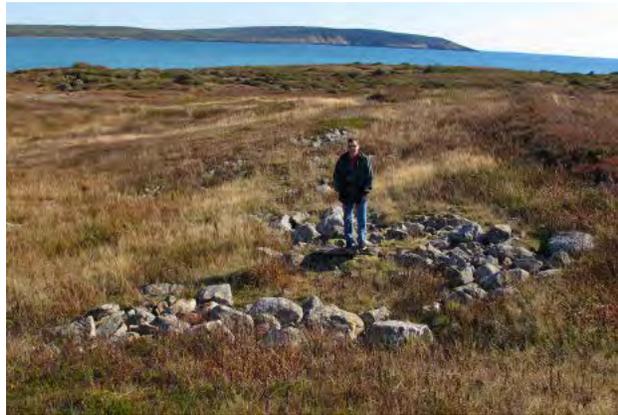
**Picture 4** An odd triangular structure (right), located at 2 o'clock in the larger circle, was investigated and might be a *fold* or similar animal control area.

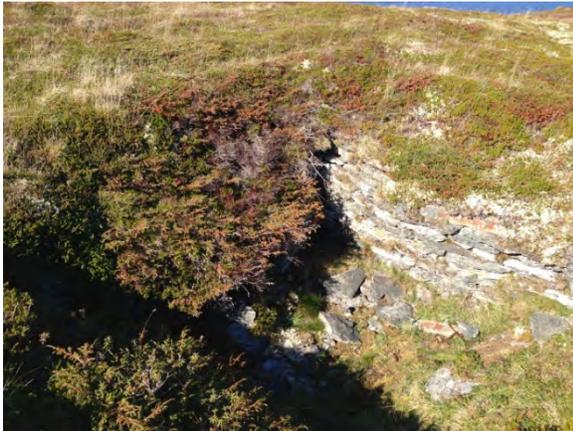
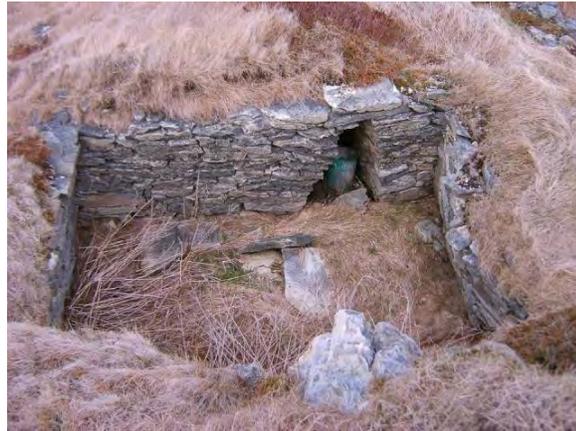
**Pictures 7 and 8** Measuring 10 feet by 10 feet inside, the Valna Fad pit (left) is similar to one (right) at Grates Cove (<http://dswa.ca/showcase/grates-cove-newfoundland>), even to the bulging wall. The Grates Cove web page suggests the walls there date from the *late 1700s to the early 1900s*; while Trepassey informants give Valna Fad a mid-19<sup>th</sup> century origin, there is no real information as to the age of the dry laid stonework in the area. The Valna Fad cellar was built into the side of a rising landscape while Grates Cove appears to have been built on level ground and buried afterwards.

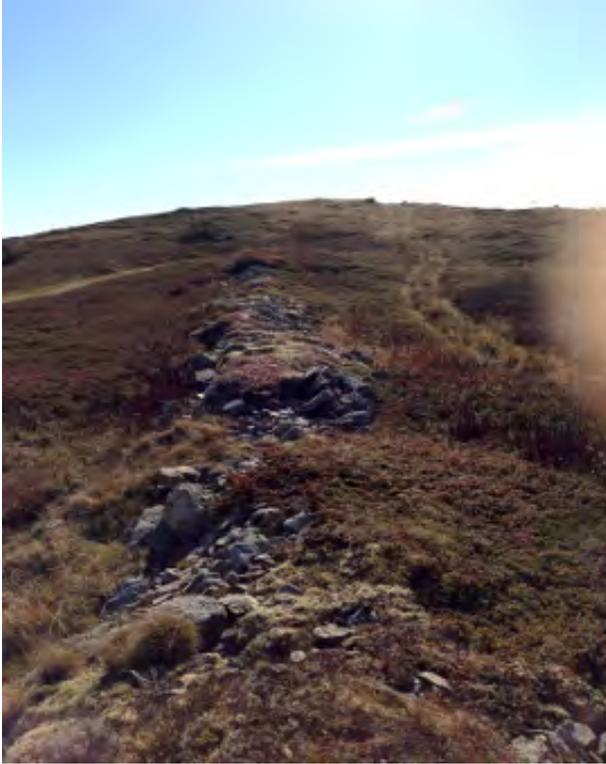
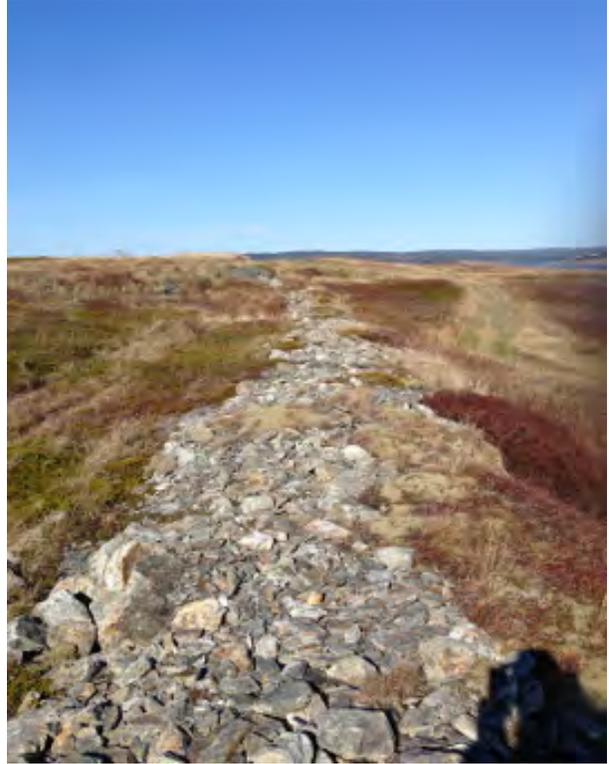
**Pictures 4 and 5** Looking up (south towards the height of land, left) and looking down (north towards Trepassey Harbour, right), about midway of the fence closest to the road. The top is quite disturbed and no dry laid stone courses can be seen among the thick shrub overgrowth. Rocks were probably removed in some sections (4, center) as they are not found collapsed at the base.

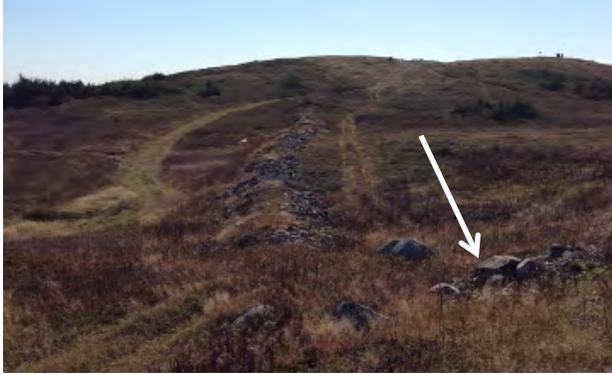
**Picture 8** The first long fence east of the road (left) descends from the south and turns to the east at lower right corner of photograph 8 (white arrow); further east it joins the second fence east of the road which parallels it.

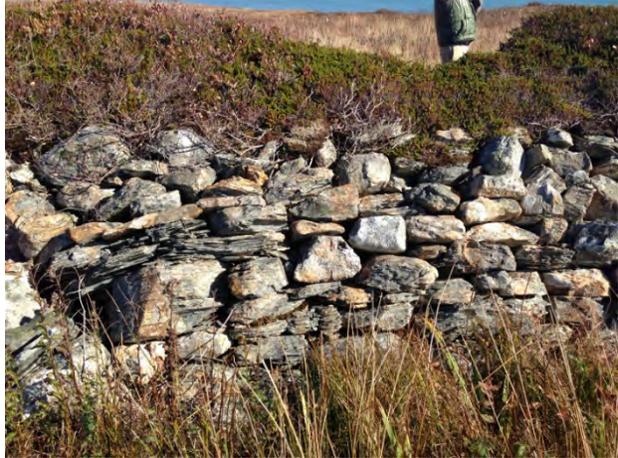
**Picture 9** The drystone courses of the second fence (right); the top is overgrown with heath-like plants and shrubs; the top can be walked.

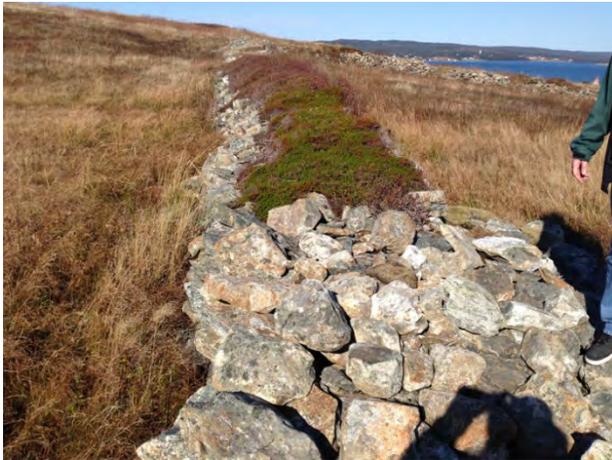
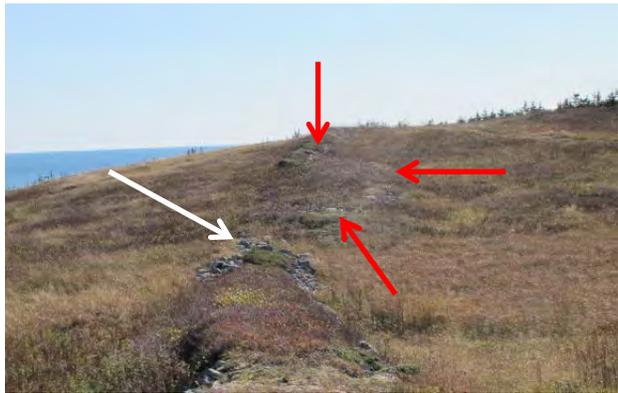
**Pictures 10 and 11** A destroyed area (white arrow in photograph 11), the drystone courses are still evident but the fencetop and central fill are missing or disturbed. This area may be the corner of a *fold* or *pound* feature, a three sided extension of the wall as shown in a forshortened view in photograph 11 (marked with red arrows).

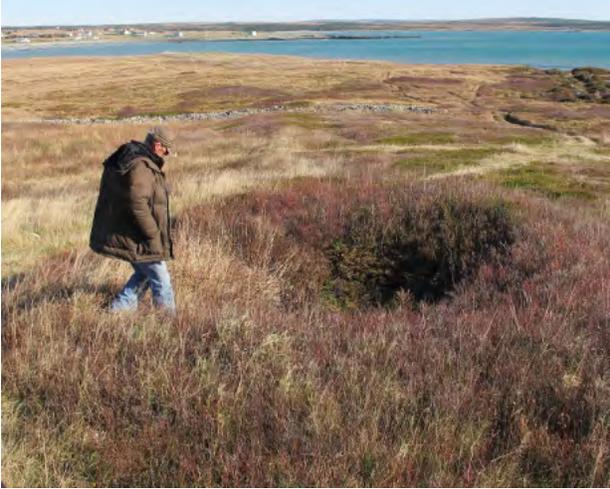
**Picture 12** Cellar pit about mid-point on Lower Coast slope and “well-built” section of middle fence.

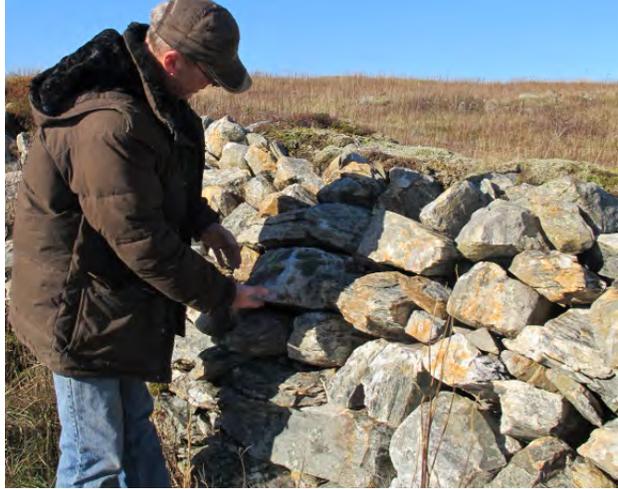
**Picture 13** Checking a “well-built” section of the middle fence.

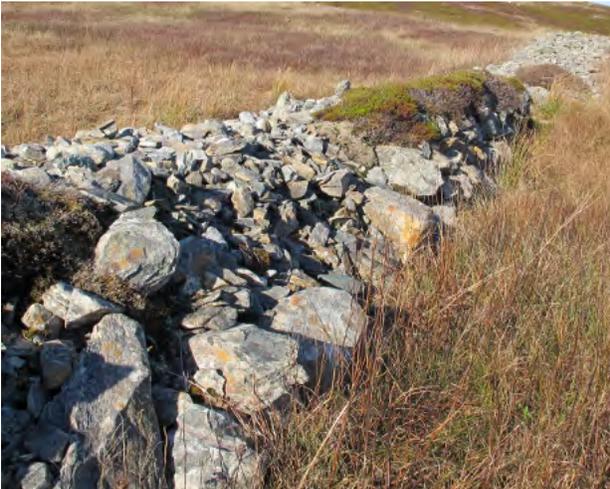
**Picture 14** This section of middle fence shows little deterioration considering that it hasn't been maintained for some time.

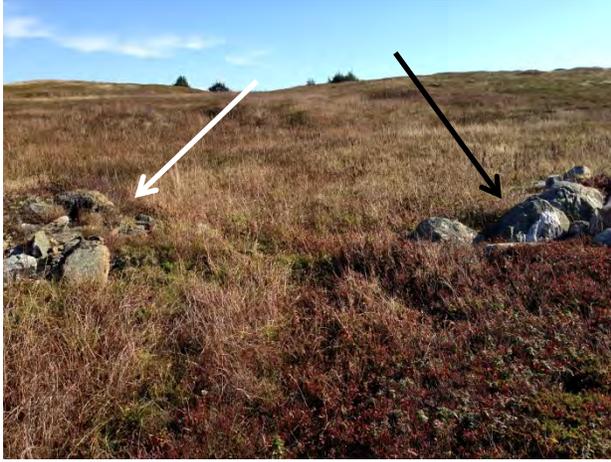
**Picture 15** A *gate*; the east side of the gate (black arrow) has a lot of piled rocks (right); the west gatepost (white arrow) incorporates a large erratic boulder or a bedrock outcrop

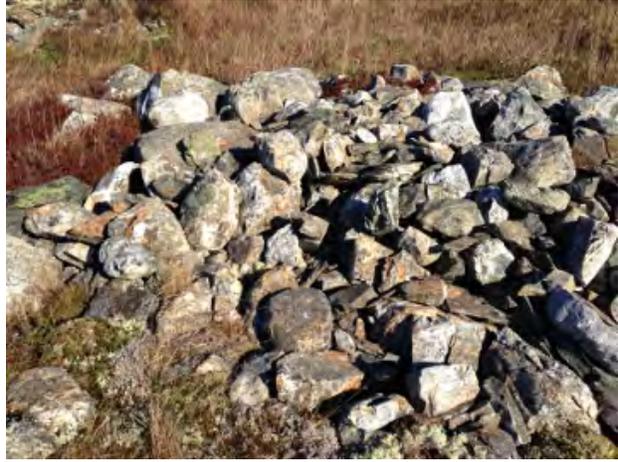
**Picture 16** East gatepost; the rocks here are larger than those used on the rest of this fence. It is possible the gate was made in the fence after construction by throwing the rocks aside.

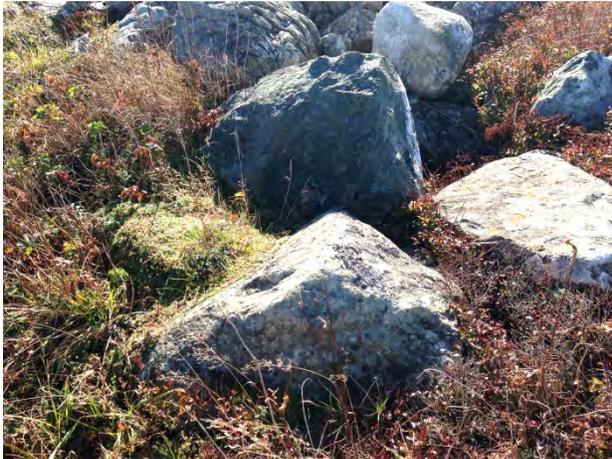
**Pictures 17** The fences here are more like piled rock and do not show any evidence of drystone courses, *unless* it is to be found under the vegetation growing along the sides. A little further south, at Valna Fad, features show intricate drystone coursing.

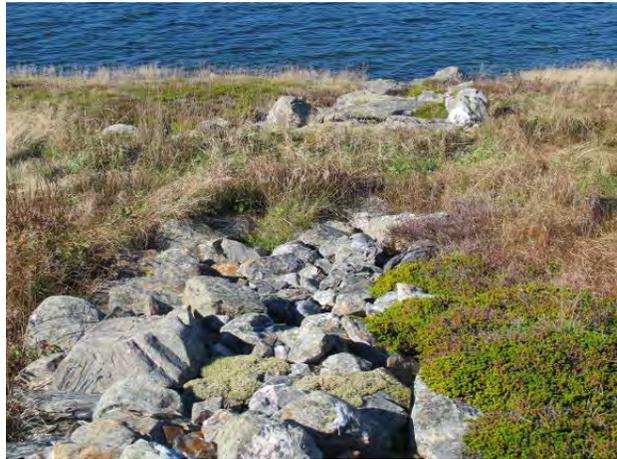
**Picture 18** A straight, drain-like feature extends west from the fences area all the way to the coastal cliff; it isn't raised like a fence and contains very large rocks and boulders haphazardly deposited.

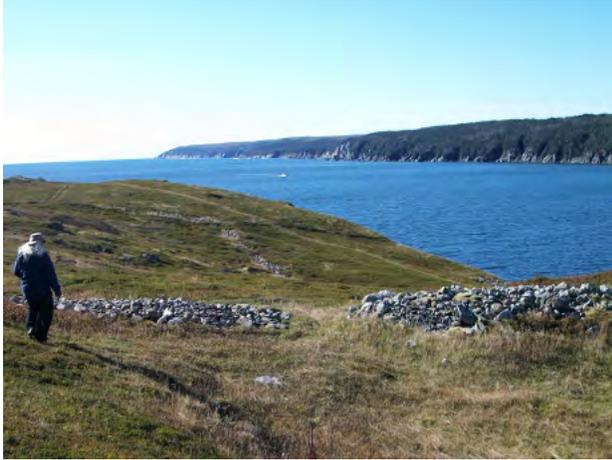
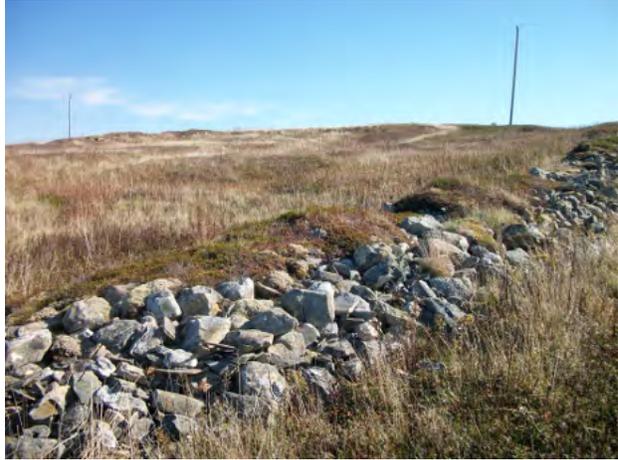
**Pictures 19 and 20** Southwest view of a *gate* made during construction; note the *piled* character, the base may have drystone work that is submerged and overgrown.

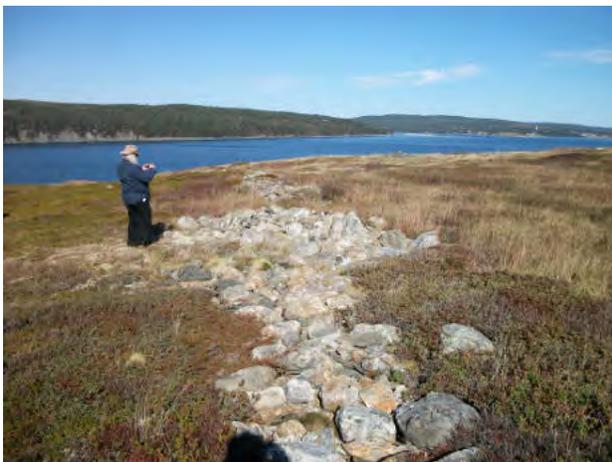
**Picture 21** Larger stone collections like this may result from simple field clearings; being level with the surface indicates they may have been piled into a ditch or natural watercourse; perhaps filling a bog hole or bedrock depression.

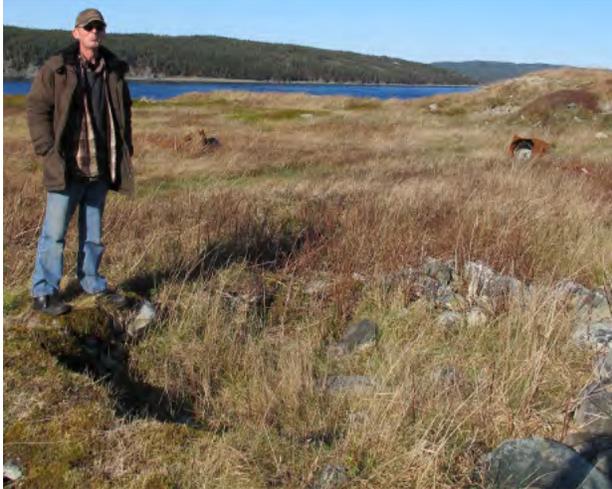
**Picture 23** Possible structure foundation with central pile, possibly a chimney or central fireplace base.

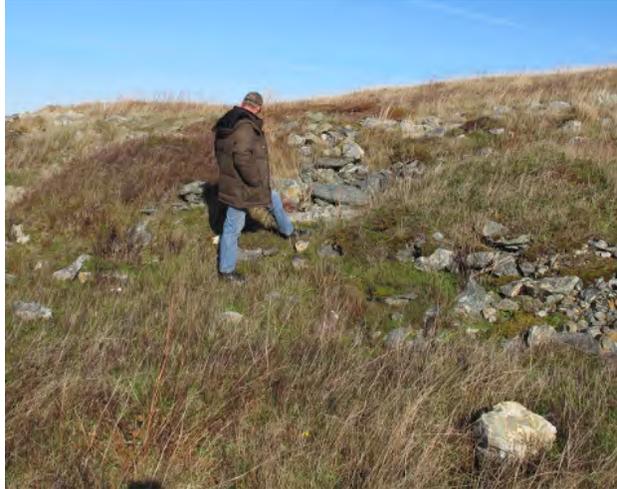
**Picture 24** A substantial rock structure; possibly two "side-by-side" cellars built against an outer wall.

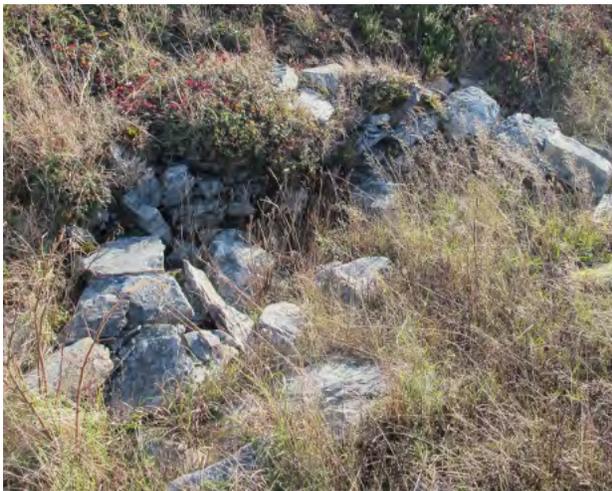
**Picture 25** Close-up of section of east side retaining wall at the base of the green slope in the foreground of picture 26.

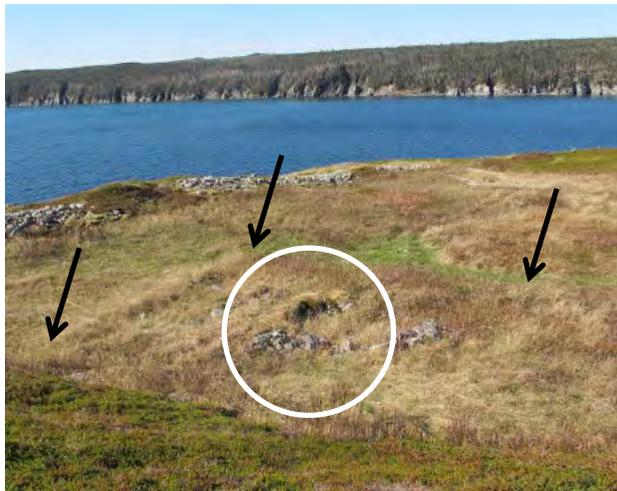
**Picture 26** West view over pit and large, levelled area defined by possible foundation walls. White circle shows a central feature, possibly a chimney or hearth; black arrows show the corners of the rectangular, flat area. The feature of picture 25 lies under the green sloped area in the foreground.

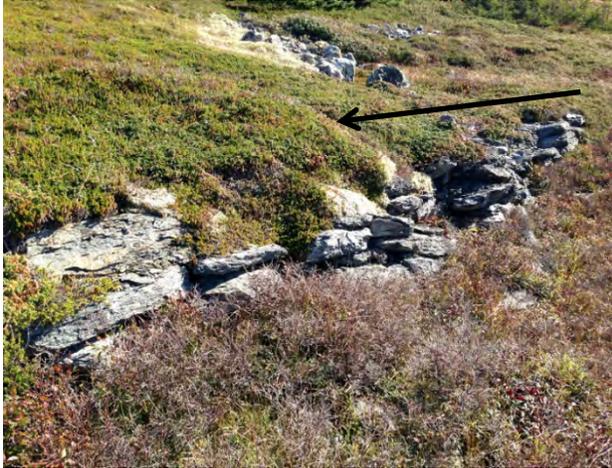
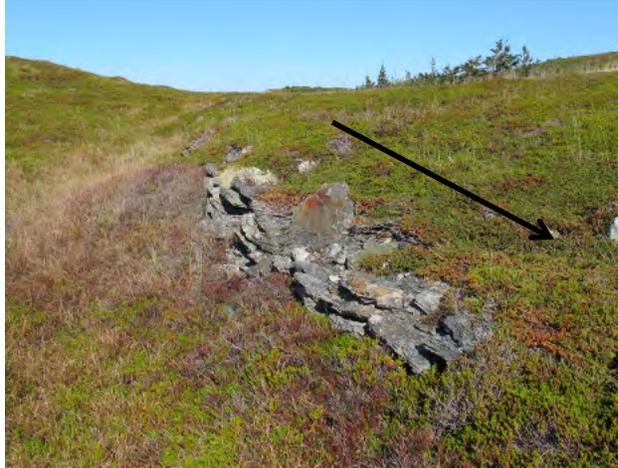
**Pictures 27 and 28** Valna Fad site has a ca. 20m long drystone retaining wall (south view left; north view right) creating a flat area to the east contains a shallow pit (black arrows), well grown over and without clear dimensions.

Early flooring in barns, cellars, storage areas, and even some houses, were often *paved* with flat stones instead of loose gravel or pounded earth. A coastal cart path runs south ending at Valna Fad site. At Valna Fad, the east side of the path is retained by a dry laid wall. East of the south end of the wall is a shallow overgrown pit; a little north of that and raised slightly, is an area of flat stones. Each feature is about 15m<sup>2</sup>.

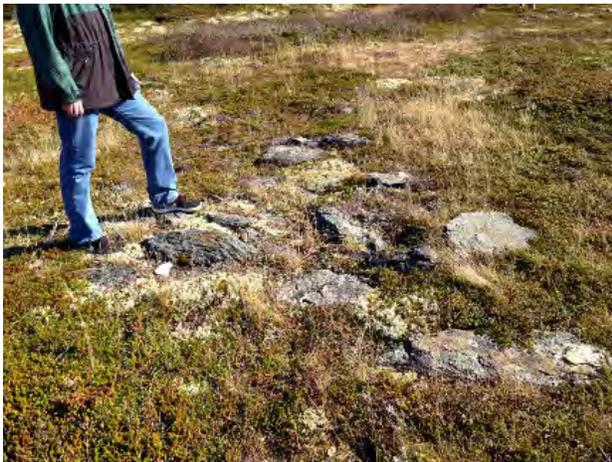
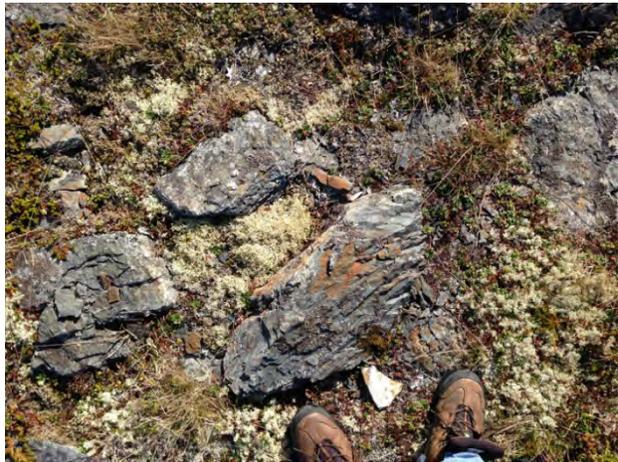
**Pictures 29 and 30** North of and slightly elevated above the Valna Fad shallow pit appears to be a flat, built-up area.

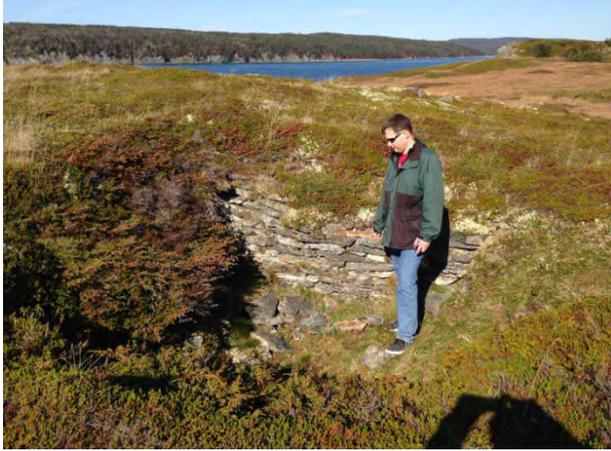
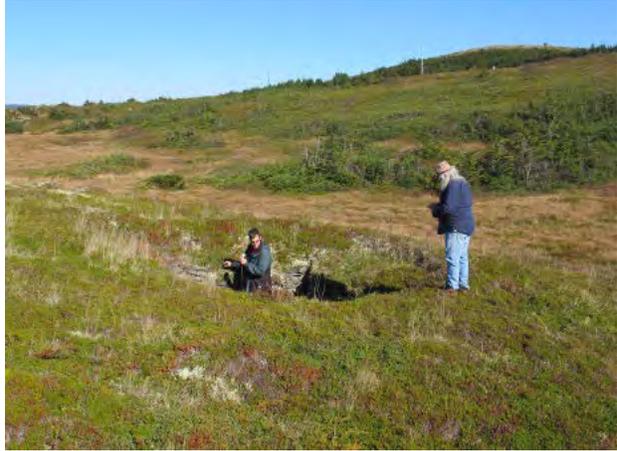
**Pictures 31 and 32** Valna Fad site possible cellar (west view left, east view right). The door and front wall have fallen in; the north wall (to observer's right) is bulging in; all four sides are overgrown. The finished inside dimension is 10 feet by 10 feet. Some stone looks worked and is of fairly consistent thickness. It was built into a rise of land and was likely partially buried on the east face.

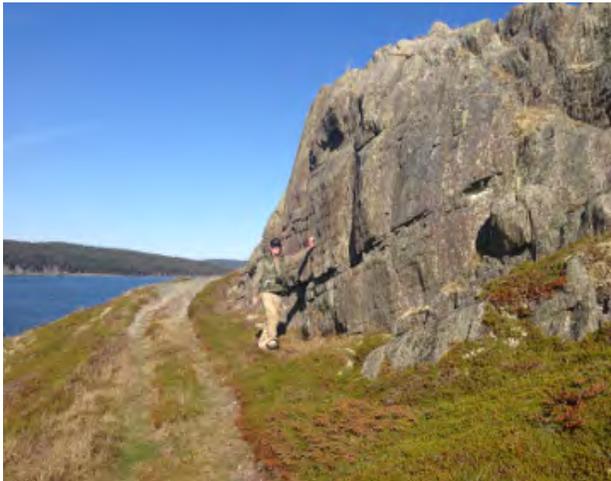
**Pictures 33 and 34** North view of an outcrop north of Valna Fad site and a possible source for the rock used at Valna Fad; the road is well used by all-terrain vehicles; there aren't any fallen stones at the base of the face. The surface has little or no lichen on what appears to be a worked face (right) while an unworked area a little north is almost completely encrusted. There no chisel or drill marks obvious.

Stone-paved floors dating from the 17<sup>th</sup> century are featured at Ferryland and at the plantation building observed at Renew's, as reported in various numbers of the *Avalon Chronicles*. The Valna Fad floor is made of the same rock as the cellar wall and the retaining wall; all may have been quarried from a large sedimentary rock outcrop to the north of Valna Fad; The features observed at Valna Fad and the outcrop are pictured in Appendix A – Photographs.
